# Manhole Inspection Summary

Manhole # S17CC1055MH

**Inspection** ☐ Is Incomplete Rating: **3) Fair**

**Location** Address: **GREENSPRING AVE** Cross Street: **EDGEGREEN AVE**

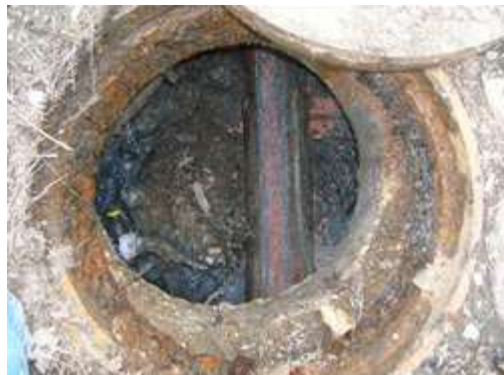
Top View

**Bench** ☒ Exists Material: **Brick** ☐ Parged ☒ **Debris** (not Condition related)  
Condition: ☒ Sound ☐ Cracked ☐ Root Intrusion ☐ Deteriorated ☐ Leaks ☐ Debris

**Steps** Count: **1** Missing: **0** ☒ **Corroded**

**Surcharge** ☒ **Evidence Of Surcharge** Depth: **1.5** (ft.) ☐ Active Surcharge Present

Corroded steps. Evidence of surcharge - Bench debris.

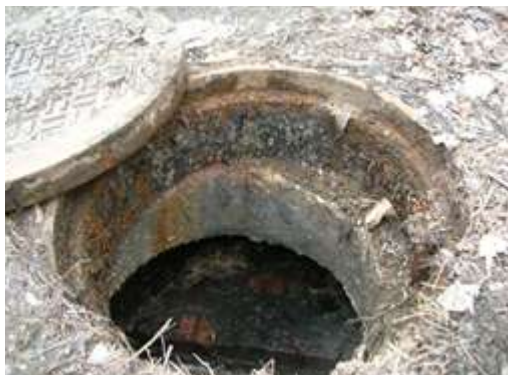
Defect

**Frame** Offset: **3** (in.) Condition: ☐ Sound ☐ Cracked ☒ **Leaks**

**Barrel** Material: **Precast Concrete** ☐ Parged  
Shape: **Circular** Diameter: **42** (in.) Length: (in.)  
Condition: ☒ Sound ☐ Cracked ☐ Root Intrusion ☐ Loose Brick ☐ Deteriorated  
Infiltration: ☐ None ☐ Joint ☐ Cracks ☐ Mortar ☐ Roots ☒ **Wall**

Frame leaks. Frame offset. Adjustment root intrusion, and infiltration. Barrel infiltration.

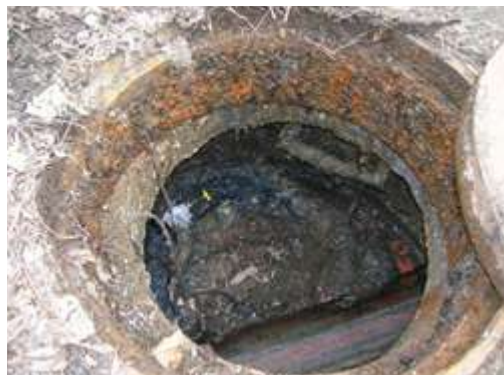
Defect

Frame leaks. Frame offset. Adjustment root intrusion, and infiltration. Barrel infiltration. - other side.

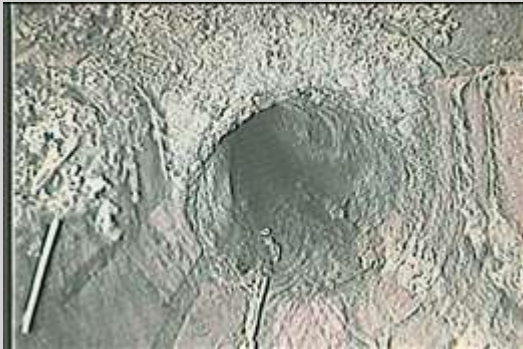
### 8 in. Circular Gravity Sewer Pipe Out @ 12 O'Clock

Deposits: ☐ None ☐ Mud ☐ ~~Gravy~~ ☒ Debris ☒ Grease

Silt Depth: **0** (in.) Deposits Extent: **Light**

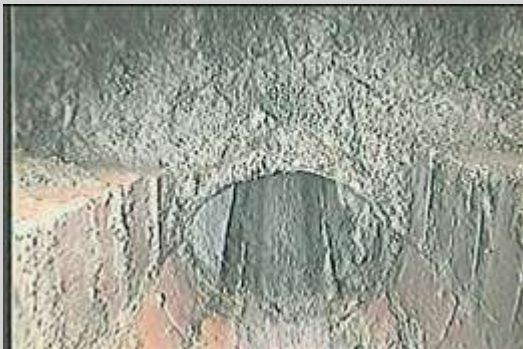
### 8 in. Circular Gravity Sewer Pipe In @ 6 O'Clock

Deposits: ☐ None ☐ Mud ☒ ~~Gravy~~ ☐ Debris ☒ Grease

Silt Depth: **0.5** (in.) Deposits Extent: **Light**
